# Arboricultural Report

Tree Survey,  
Arboricultural Impact Assessment &  
Arboricultural Method Statement

**Flemington Lane  
Balbriggan  
Co. Dublin**

**260220-PD-11-A**

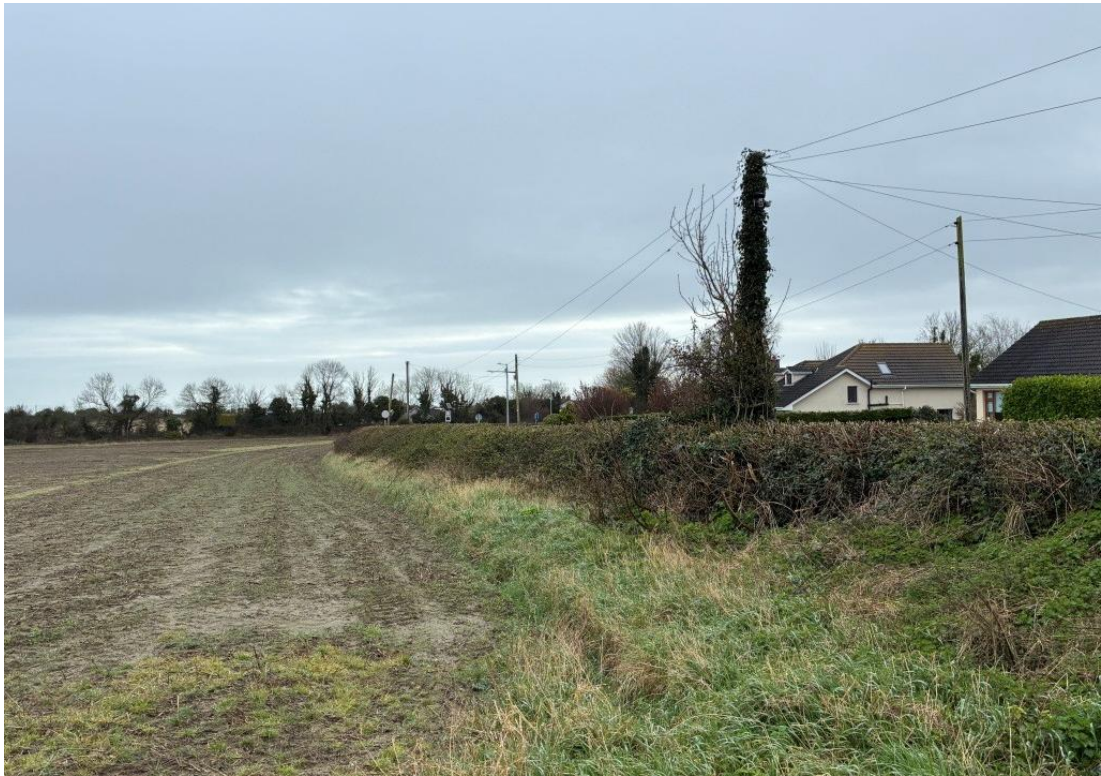
**Photo 1:** View of the maintained southern boundary hedgerow H32.

| Tree ID | No. Species | Height (m) | Stem diameter (cm) | No. of Stems | CROWN SPREAD (m) | | | | | | | | Crown clearance (m) | L.B. (m) | Life stage | Condition Notes | Survey date | RPA (m <sup>2</sup> ) | RPR (m) | Life expectancy (yrs) | BS Category |
|---|---|---|---|---|---|---|---|---|---|---|---|---|---|---|---|---|---|---|---|---|---|
| Hedge H32 | 1 | Rubus fruticosus s. (Blackberry/Bramble) | 1.5 | 10 AVE | 1 | | | | | | | | 0.0 | | Early Mature | Structural condition Good. Physiological condition Good. Hedgerow - Maintained. Maintained dense agricultural hedgerow at 1- 1.5m height. Mostly consists of hawthorn and bramble. Breasted on roadside.2-3m wide. Quantities not recorded, only species mix.Diameters and height recorded as average for group. | 18/03/2026 | 4.5 | 1.2 | 20-40 | C2 |

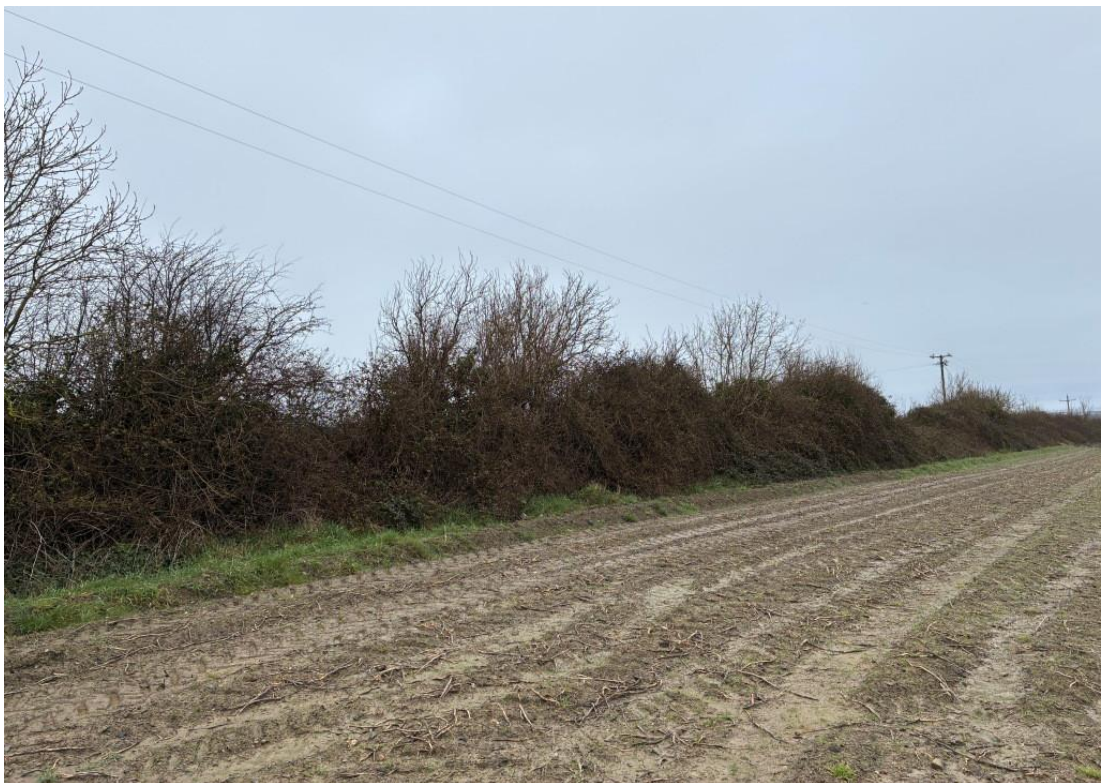
**Photo 2:** View of the western boundary native hedgerow H34.

| Tree ID | No. Species | Height (m) | Stem diameter (cm) | No. of Stems | CROWN SPREAD (m) | | | | | | | | Crown clearance (m) | L.B. (m) | Life stage | Condition Notes | Survey date | RPA (m <sup>2</sup> ) | RPR (m) | Life expectancy (yrs) | BS Category |
|---|---|---|---|---|---|---|---|---|---|---|---|---|---|---|---|---|---|---|---|---|---|
| Hedge H34 | 1 Rubus fruticosus s. (Blackberry/Bramble) | 6.0 | 25 AVE | 1 | | | | | | | | | 0.0 | | Mature | Structural condition Fair. Physiological condition Fair. Hedgerow - Neglected / overgrown. Height and stem diameter are average for group. Mixed hedgerow consisting mainly of regrown Ash at 7m. Dense bramble clads the lower and mid canopies of trees. Ash trees showing signs of Ash die back at varying stages. Quantities not recorded only species mix. | 18/03/2026 | 28.3 | 3.0 | 20-40 | C2 |

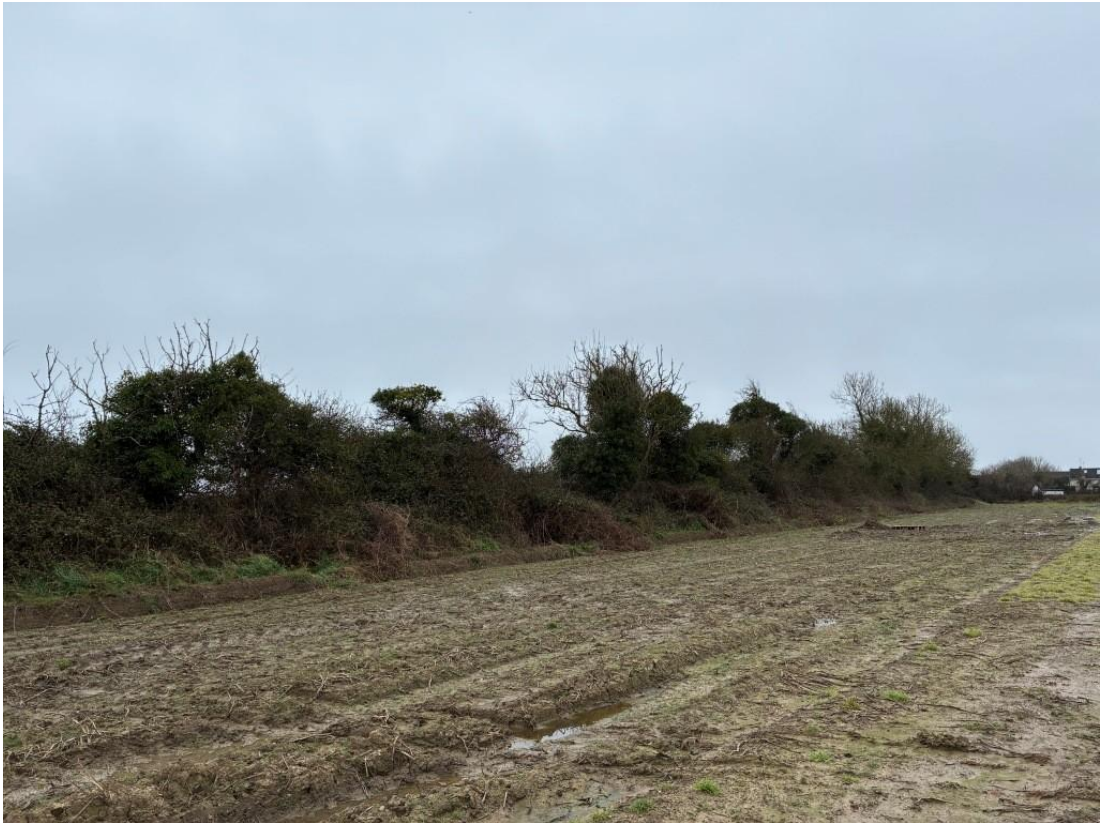
**Photo 3:** View of the central moderate quality native hedgerow H22.

| Tree ID | No. Species | Height (m) | Stem diameter (cm) | No. of Stems | CROWN SPREAD (m) | | | | | | | | Crown clearance (m) | L.B. (m) | Life stage | Condition Notes | Survey date | RPA (m <sup>2</sup> ) | RPR (m) | Life expectancy (yrs) | BS Category |
|---|---|---|---|---|---|---|---|---|---|---|---|---|---|---|---|---|---|---|---|---|---|
| Hedge H22 | 1 Sambucus nigra (Elder) | 6.0 | 25<br>AVE | 1 | | | | | | | | | 0.0 | | Mature | Structural condition Fair. Physiological condition Fair. Hedgerow - Neglected / overgrown. Height and stem diameter are average for group. Mixed native hedgerow consisting mainly of hawthorn. Several gaps present that are overgrown with brambles. Quantities not recorded only species mix. Young ash trees are in decline as they are infected with ash dieback. | 18/03/2026 | 28.3 | 3.0 | 20-40 | B2 |

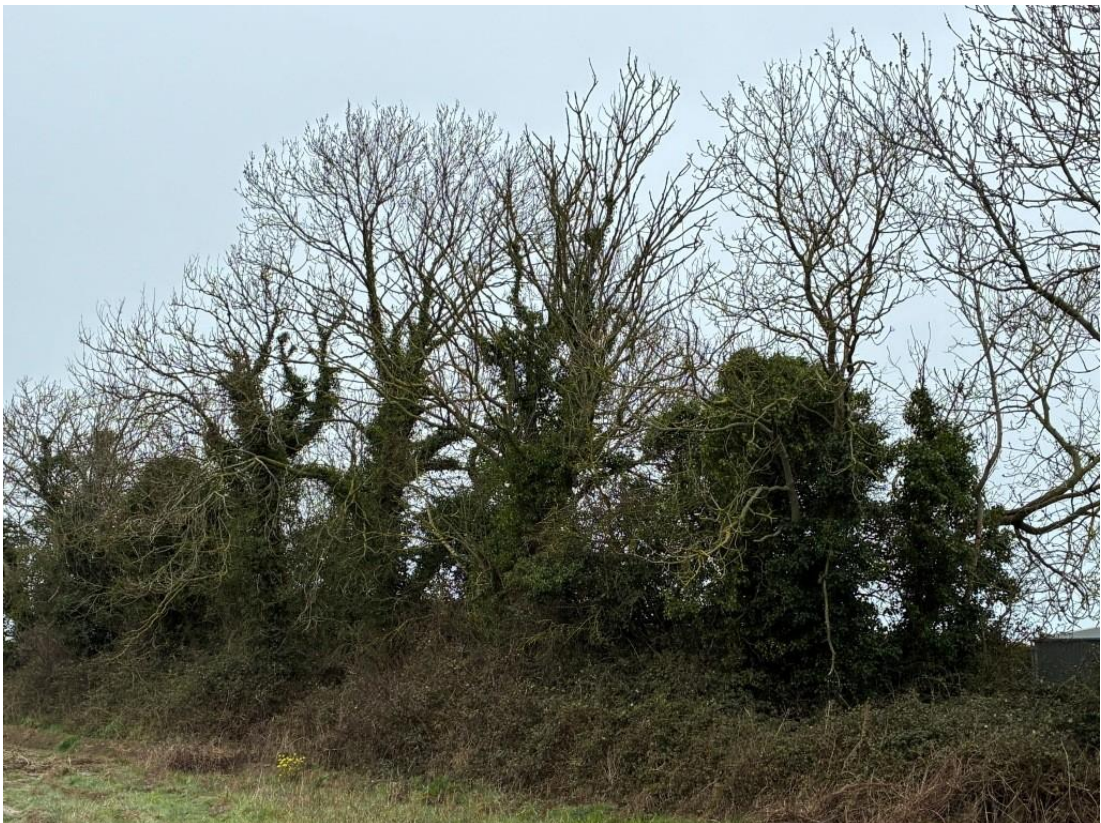
**Photo 4:** View of the tree group consisting of early mature ash trees regrown from historic coppicing, with an understory hedgerow consisting of hawthorn.

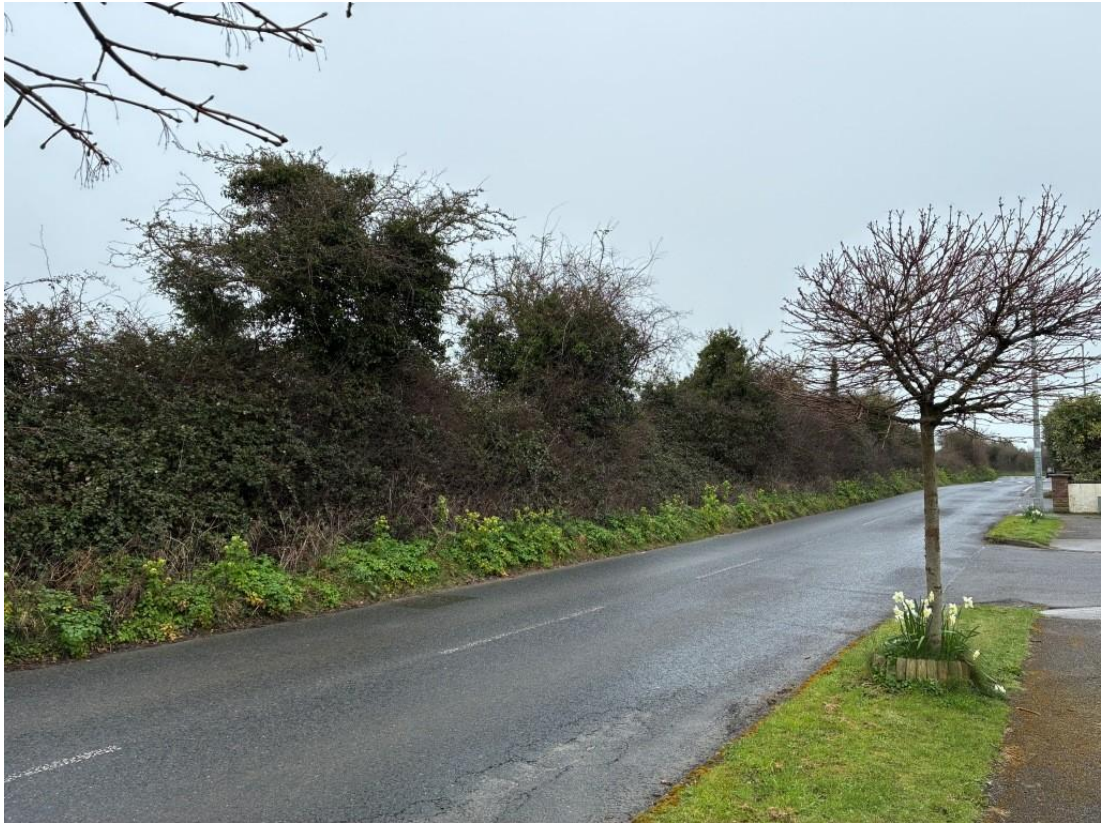
**Photo 5:** *View of the southern boundary native hedgerow H31.*

| Tree ID | No. Species | Height (m) | Stem diameter (cm) | No. of Stems | CROWN SPREAD (m) | | | | | | | | Crown clearance (m) | L.B. (m) | Life stage | Condition Notes | Survey date | RPA (m <sup>2</sup> ) | RPR (m) | Life expectancy (yrs) | BS Category |
|---|---|---|---|---|---|---|---|---|---|---|---|---|---|---|---|---|---|---|---|---|---|
| Hedge H31 | 1 Sambucus nigra (Elder) | 6.0 | 27 AVE | 1 | | | | | | | | | 0.0 | | Mature | Structural condition Fair. Physiological condition Fair. Hedgerow - Neglected / overgrown. Height and stem diameter are average for group. Mixed roadside native hedgerow consisting mainly of hawthorn. Young ash are in decline as they are infected with ash dieback . Quantities not recorded only species mix. Overgrown hedgerow in need of some rejuvenation works. | 18/03/2026 | 33.0 | 3.2 | 20-40 | B2 |

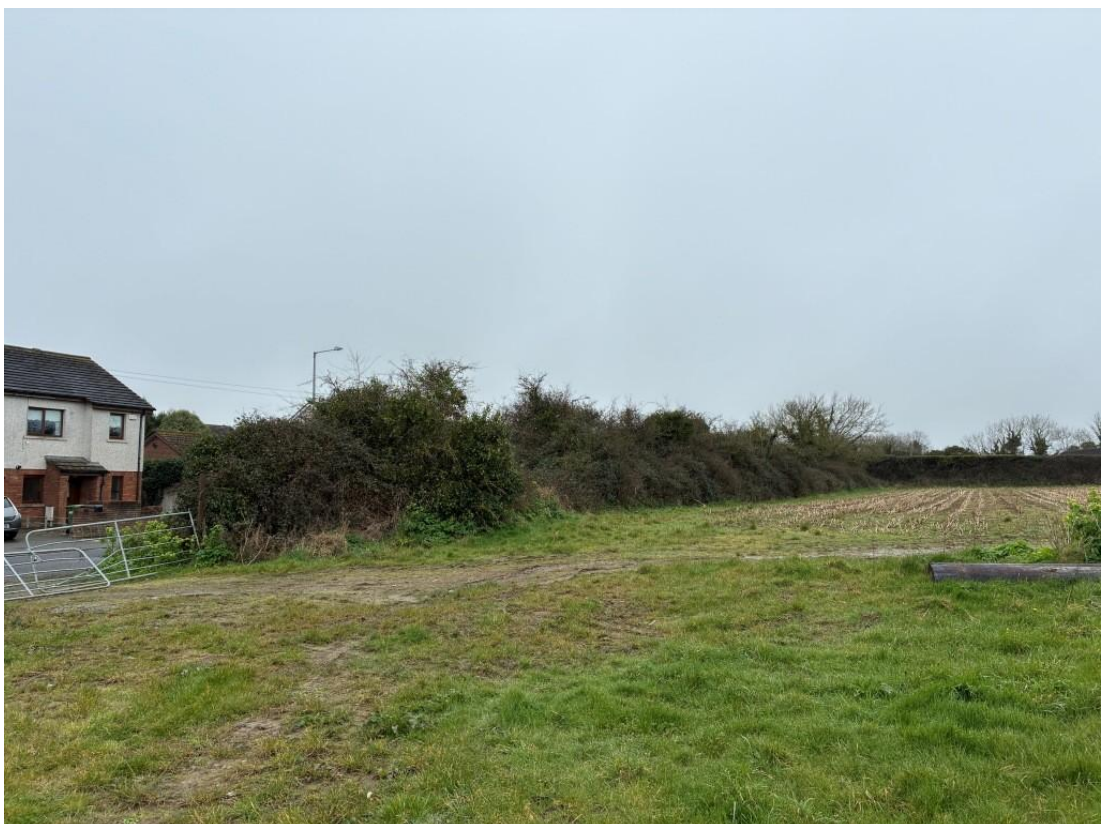
**Photo 6:** *View of the native hedgerow H31 from within the site.*
